“Out of sight, out of mind” problem for dryer section gears can lead to unexpected gear failure caused by harsh machine conditions

BY AL LANKFORD and RUSS FOX

Scheduled Dryer Gear Inspection Reduces Unscheduled Downtime

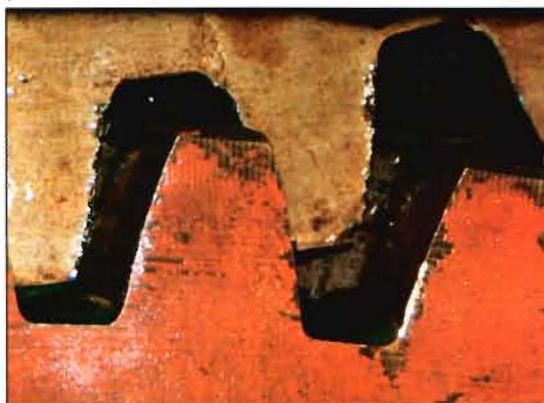
FIGURE 1: Misalignment is one of the easiest problems to spot.

Misalignment. When the gears are not properly aligned, the drive loads are concentrated at the edge of the teeth resulting in higher compressive loads, accelerated wear, uneven wear, and ultimately, failure (Figure 1).

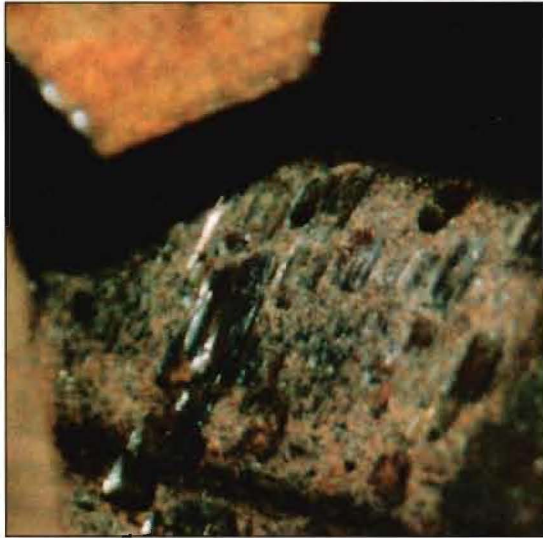
FIGURE 2: Scoring is caused by a failure of the lubricant film.

Scoring. More radical scratching and grooving on the tooth is caused by a failure of lubricant film during localized overheating of the gear mesh (Figure 2). The resulting metal-to-metal contact can cause rough points on the tooth flanks to weld together instantaneously. As the rotation continues, the welds break, tearing out tooth material. Left unchecked, scoring can remove sufficient metal over time, resulting in destructive wear. The root cause of scoring damage is often fatigued or improper lubricant and/or inadequate lubricant filtration.

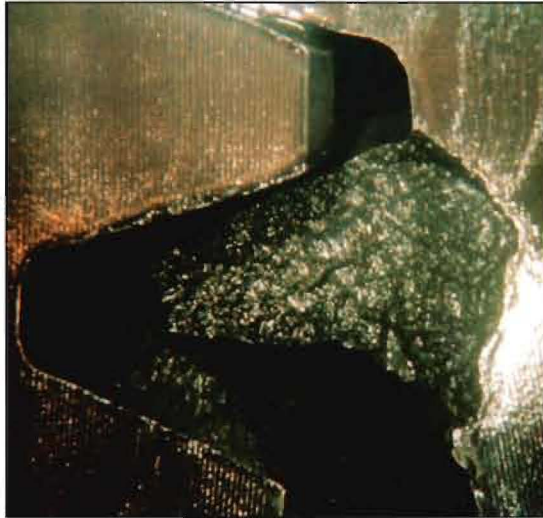
FIGURE 3: Fatigue breakage results from repeated bending stresses greater than the endurance limit of the gear.

Fatigue breakage. When bending stresses greater than the endurance limit of the gear are applied repeatedly, breakage can ensue (Figure 3). Cracks begin to form in the root on the loaded side of the tooth—the area subject to the greatest tensile stress. Under continued stress, the cracks propagate until tooth failure occurs. While operation beyond recommended wear limits is the most common cause of breakage, skewed loading from misalignment can also cause this type of damage.

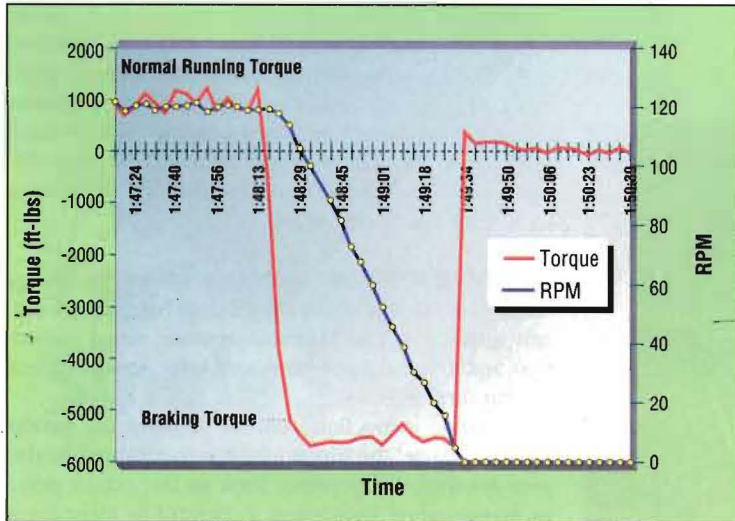
FIGURE 4: Sudden deceleration can increase torque loads substantially.

loads, which stress the gear beyond its endurance limits. A common cause of such overloads is inappropriately high acceleration and/or deceleration rates. Many paper mills have elected to reduce the deceleration time of their paper machines. This is sometimes accomplished by the installation of auxiliary brakes on the dryer section in-drives. This practice can result in substantial deceleration torque forces (Figure 4). This, of course, produces severe

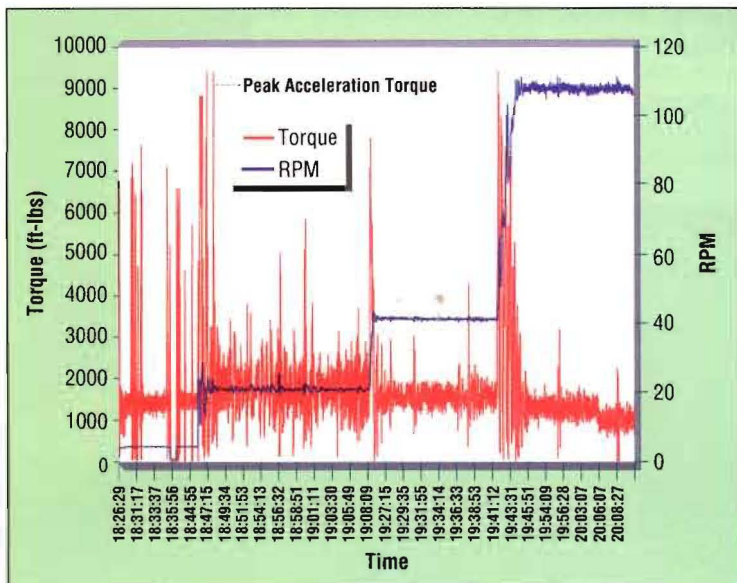
FIGURE 5: Torque overload can also occur during quick accelerations.

Overload stresses can also occur during acceleration cycles (i.e., when acceleration rates are excessive), resulting in tooth breakage during the startup cycle (Figure 5). Hard starting clutches and misalignment can also cause gear failure due to overloading.

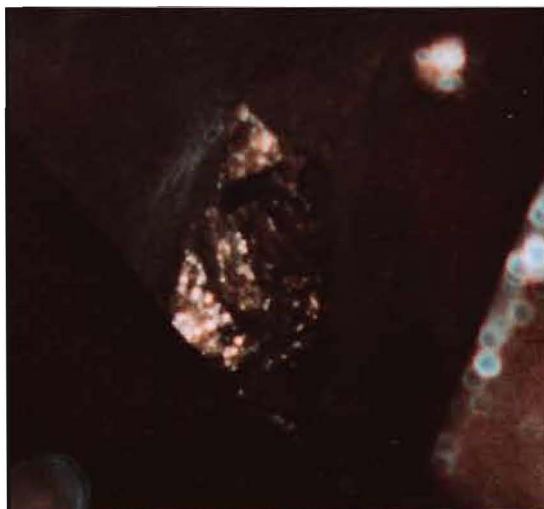
FIGURE 6: Localized failure is caused by large contaminants passing through the gear mesh.

Localized failure. The passage of large contaminants through the gear mesh can result in localized failure (Figure 6). Although the damage might appear to be minor (i.e., some operators might be tempted to return the gear to operation), any defect in a gear

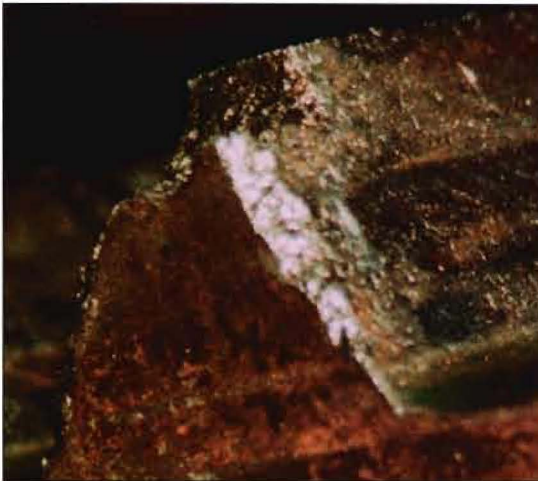
Destructive wear. Excessive wear causes tooth-shaped deterioration (Figure 7). Such wear can be caused by any one, or a combination of, the various types of surface wear which are described above. If

not corrected by replacement of the affected gear(s), destructive wear can result in a catastrophic failure of gear teeth. In enclosed gear assemblies, this type of failure can cause the destruction of the entire gear section.

FIGURE 7: Destructive wear is the deterioration of the tooth shape caused by excessive wear.

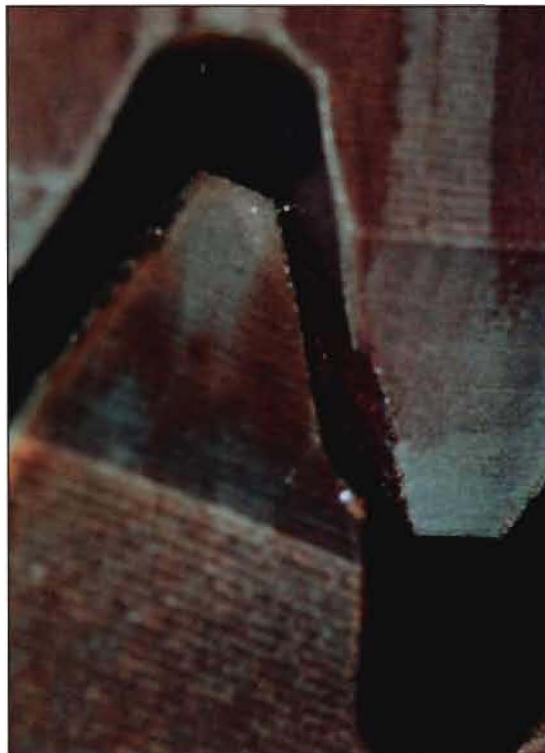
Fluctuation in the backlash, or in "tip-to-root" clearance, indicates that the gear is not concentric, that the journal upon which it is mounted is bent, or that the

center-to-center distance between gears has shifted (Figure 8). Excessively tight (or loose) backlash, or excessive tip-to-root clearances, indicate a worn bearing, misalignment, or worn gear teeth.

FIGURE 8: Excessive backlash can be caused by service-induced increases in the center distance between the mating gears.
