The ability to “freeze” a gear while the machine is in operation can help a properly trained technician safely inspect performance

Strobe Inspection of Dryer Gears Helps Identify Problems, Plan Maintenance

By AL LANKFORD

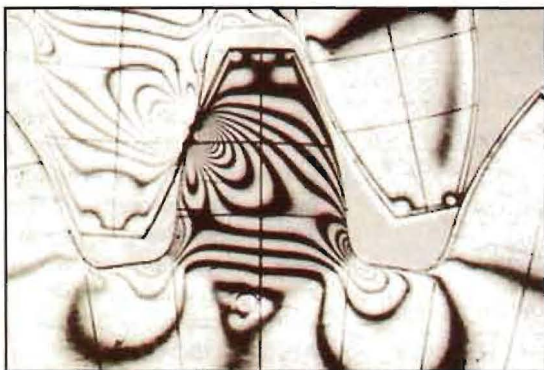
FIGURE 4. The stress points in mating gears are illustrated.

Figure 4 illustrates the stresses of two mating teeth receiving full load.¹ Although there are high compressive stresses at the point of contact, the tensile stress is concentrated at the root radius and is thereby the most common point of failure. Excessive backlash caused by an increase in the center distance between the gears increases the moment arm on the mating teeth and the tensile stress at the root radius, often resulting in vibration, fatigue, and failure.

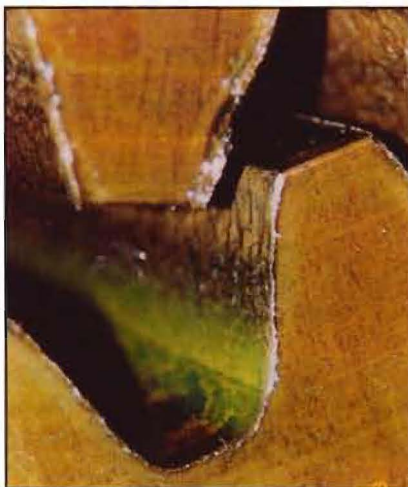
FIGURE 3. This photo shows misalignment caused by axial run-out.

Viewing the gear mesh from the side, if there is a variation in the edge relationship, is an indication of axial run-out in one or both of the gears, a gear not true

on the journal, or a bent journal (Figure 3).
